Engineering–geological investigation of the river bottom near a dam’s stabilization threshold based on two different evaluation methodologies

Keywords Engineering–geological investigation · Threshold · Vistula River alluvium · Włocławek dam · Geodetic/bathymetric measurements

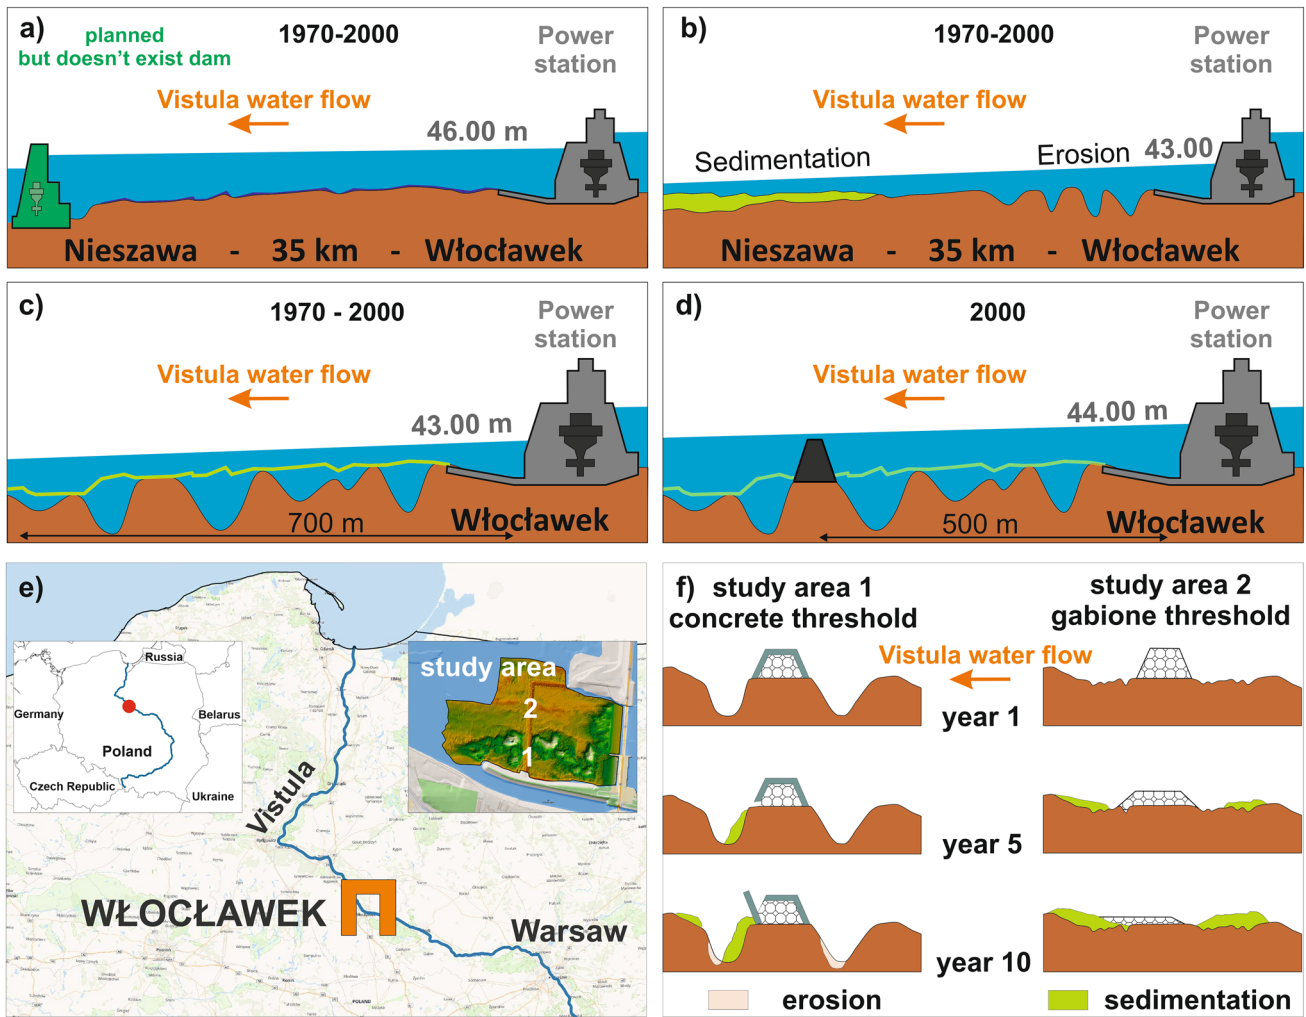
The realization of the investment contrary to the original plan (Fig. 1a) had a very adverse effect on the formation of the bottom. The current construction (Fig. 1b) has a destructive impact on the bottom due to the formation of numerous holes (Fig. 1c). The situation in the study area was partially addressed by building thresholds (Fig. 1d), but the formation of potholes continues and the thresholds are endangered. The study area was divided into two sections (Fig. 1e), where the first Vistula River alluvium section is characteristic of dominant potholes and a concrete threshold (Fig. 1f1). The engineering–geological environment of the study is the Vistula River alluvium. Erosion prevails over sedimentation in the first section. The second section of the study area is specific for its gabion threshold protection (Fig. 1f2) as the river bottom is not threatened by potholes, but by sedimentation. The differences are one motivation in the study.

Fig. 1 Schematic visualization of the study area, **a** planned conditions of the power plant system with more dams and expected Vistula River level, **b** real situation with only one power plant (Włocławek) with marked Vistula River level, **c** real operation of Włocławek power plant led to the formation of potholes in the Vistula River alluvium,

d the construction of a threshold changed the water regime near the power plant, but potholes keep forming, **e** map of the study area with marked sections 1 and 2, **f1** concrete threshold with potholes in section 1, **f2** a gabion threshold in section 2

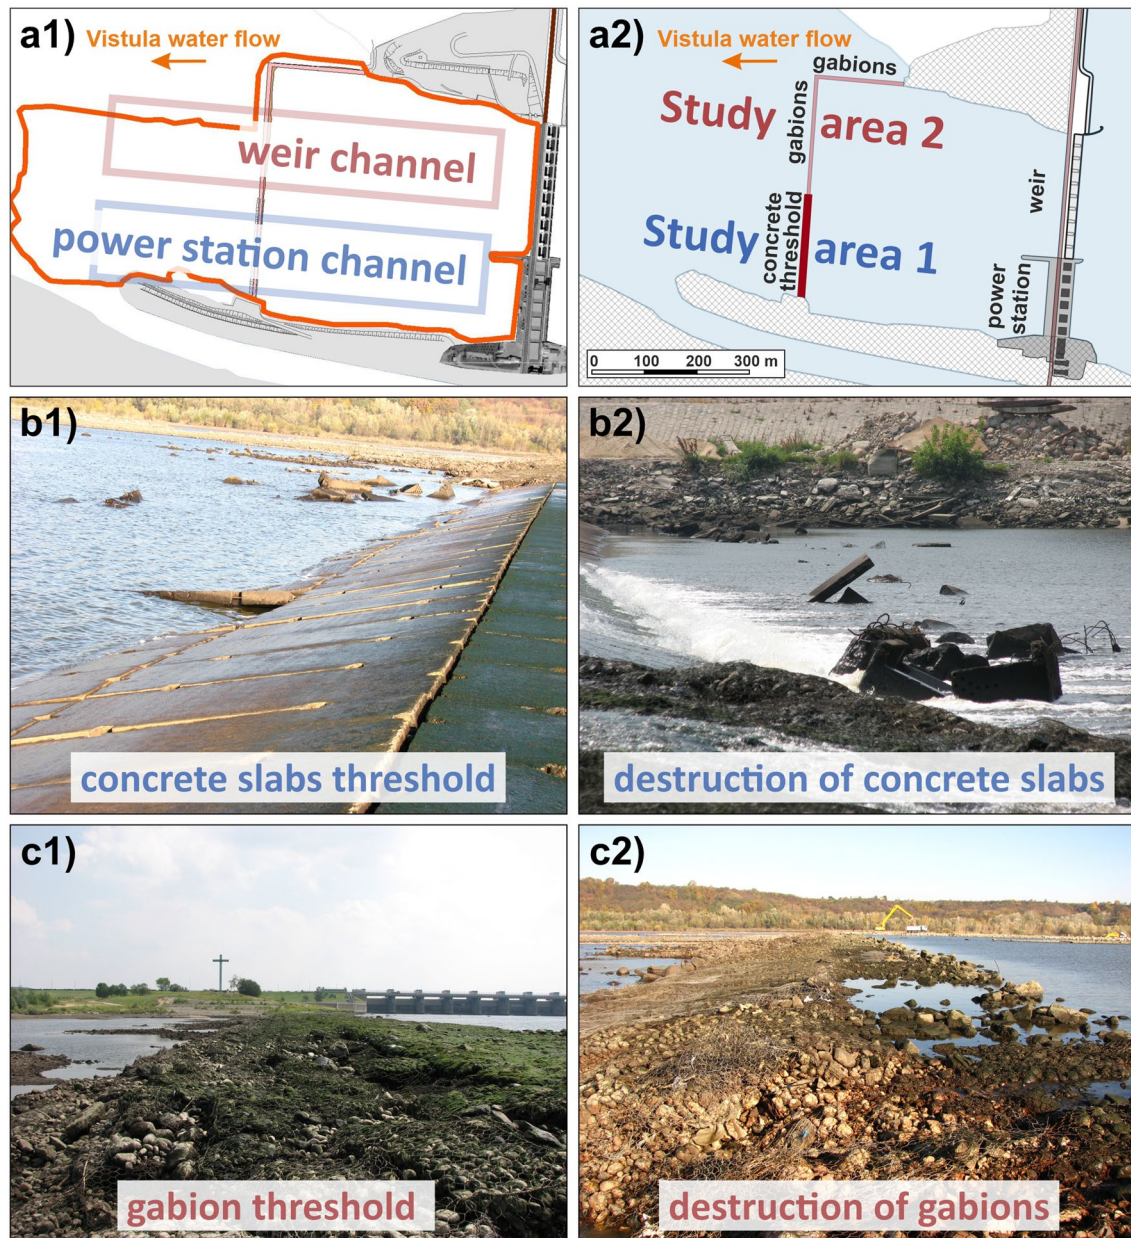
The study area section 1 (Fig. 2) is characteristic of a specific water flow as it is located downstream of a water power plant, where there is a dominant water flow in the power plant channel (Fig. 2a1, a2). This section belongs to the power plant Włocławek and the water flow is influenced by the construction of the concrete slab threshold (Fig. 2b1). On the contrary, the study area section 2 (Fig. 2a2) is a characteristic of a weir channel (Fig. 2a1) with a protective gabion threshold (Fig. 2c1). Increased water volume is observed there only during floods, when extra water must be discharged over the weir, and not only through the power plant itself. A common problem of both the study area sections 1 and 2 is the fact that both the concrete threshold (Fig. 2b2) and the gabion threshold (Fig. 2c2) suffer from damage.

Fig. 2 Photo-documentation of the damaged thresholds in the study area sections 1 and 2, **a1** weir channel in study area 1 and power station channel in study area 2, **a2** concrete slabs threshold in study area 1 and gabion threshold in study area 2, **b1** photo-documentation of

the concrete threshold, **b2** photo-documentation of its destruction, **c1** photo-documentation of the gabion threshold, **c2** photo-documentation of its destruction

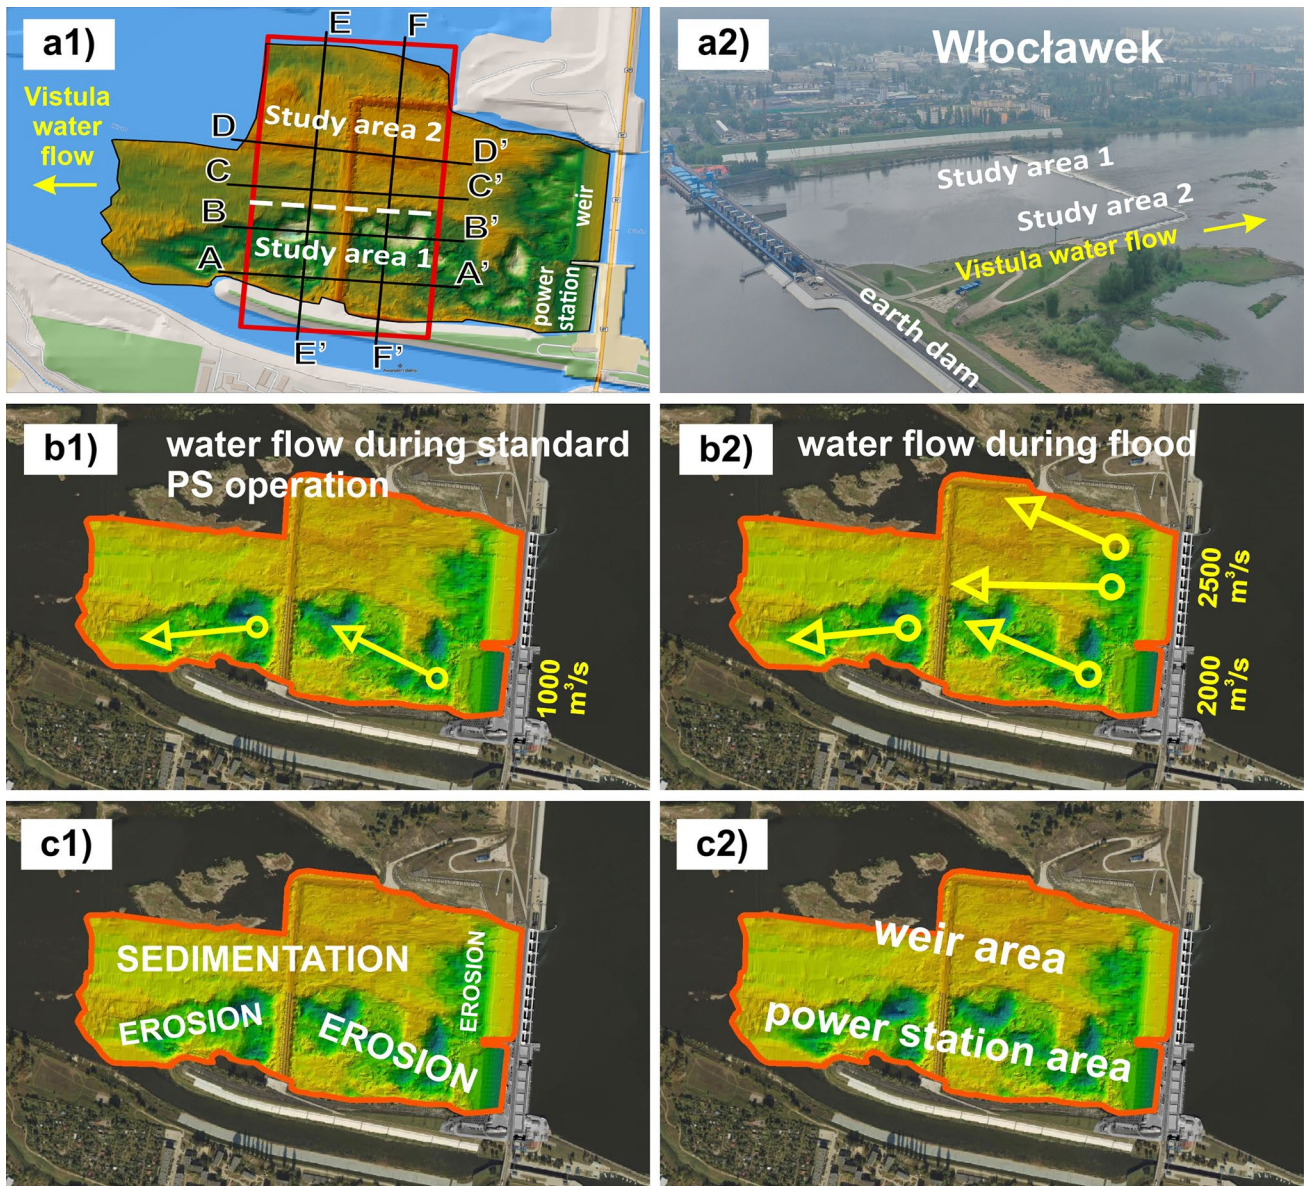
as they directly influence their stability and function. It is clear that the river bottom in study area 1 behaves differently to the river bottom in study area 2. The digital model of study area 1 river bottom shows prevailing erosion with forming potholes (Fig. 3a1, a2). On the contrary, in study area 2, this process is non-existent and it is sedimentation as a geodynamic process that occurs in study area 2. For such reasons, different methodologies must be applied in evaluation as the stability of the thresholds is influenced by different processes (Fig. 3a1, a2).

water flow (Fig. 3b1) on the left bank downstream of the power plant. This discharge is open during everyday standard operation, i.e. the power station channel, where potholes form. In study area 2, higher volumes of water flow only during the floods (Fig. 3b2), when water is discharged over the weir too. Although water is rarely discharged over the weir, the gabion threshold also gets destroyed. Having the opportunity to apply two methodologies means that the approaches may be compared. The digital model of the river bottom points at dominant erosion processes in study area 1 and sedimentation processes in study area 2 (Fig. 3c1), which correlates with the marked power station

Fig. 3 The conditions on the Vistula River bottom with marked study areas 1 and 2, **a1** a digital model of the river bottom with marked study areas 1 and 2, and cross-sections A–A', B–B', C–C', D–D', E–E' and F–F', **a2** an aerial photo of the study area, **b1** water flow

during standard power station operation, **b2** water flow during floods, **c1** dominant erosion processes in study area 1 and dominant sedimentation processes in study area 2, **c2** power plant area (study area 1) and weir area (study area 2)

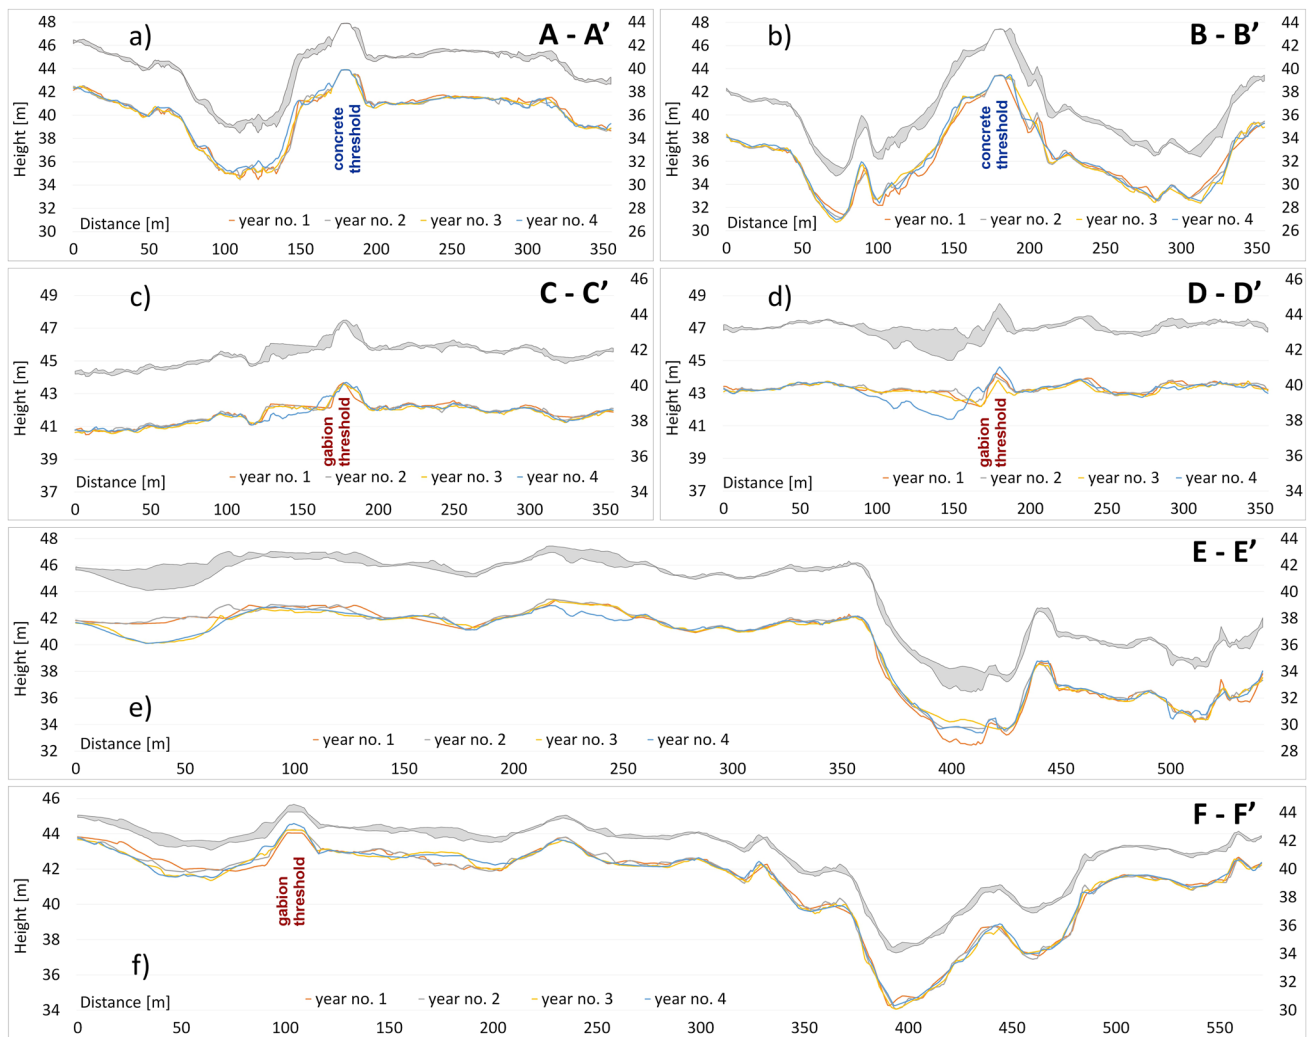
Fig. 6 Cross-sections of river bottom changes during a 4-year bathymetric monitoring in the study area (cross-sections marked in the map in Figs. 3a1 and 7g **a** cross-section A–A' with a concrete threshold (study area 1), **b** cross-section B–B' with a concrete threshold (study

area 1), **c** cross-section C–C' with a gabion threshold (study area 2), **d** cross-section D–D' with a gabion threshold (study area 2), **e** cross-section E–E' in the study areas 1 and 2, **f** cross-section F–F' in study areas 1 and 2

D–D' (Figs. 6c, d, 7c, d) as the cross-sections A–A' and B–B' have steeper slopes in the potholes. This is caused by the continuous water discharge in the power plant channel with dominant erosion processes.

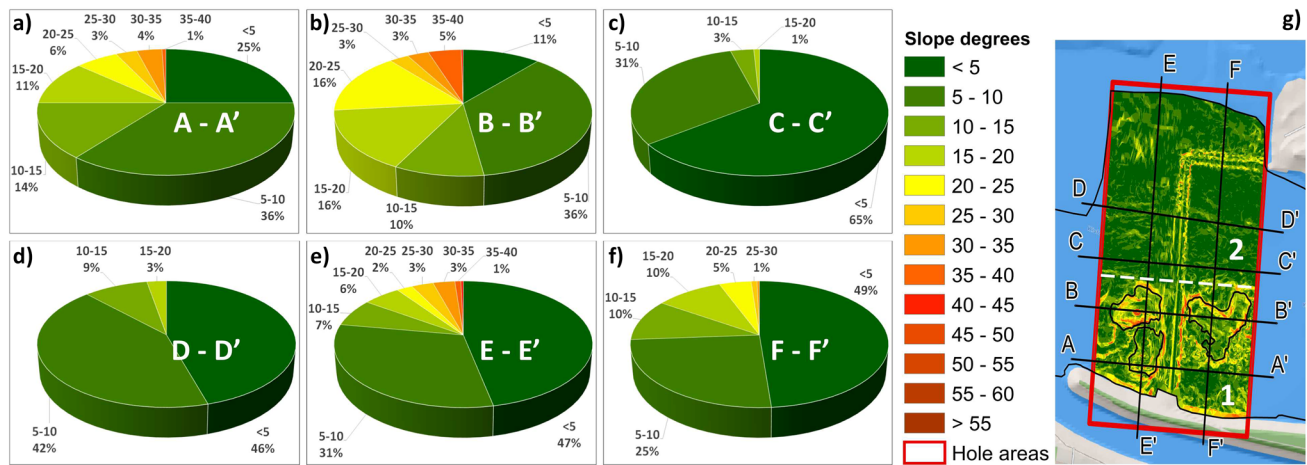
The first two cross-sections A–A' and B–B' (Fig. 7a, b) are characteristic of steeper slopes in the potholes. The percentage of slopes ($> 5^\circ$, $5^\circ\text{--}10^\circ$ and $10^\circ\text{--}15^\circ$) is from 57 to 75%, while in steeper slopes ($15^\circ\text{--}20^\circ$, $20^\circ\text{--}25^\circ$, $25^\circ\text{--}30^\circ$, $30^\circ\text{--}35^\circ$ and $35^\circ\text{--}40^\circ$), it is from 25 to 43%. In cross-sections C–C' and D–D' (Fig. 7c, d), the percentages are different. The angles ($> 5^\circ$, $5^\circ\text{--}10^\circ$ a $10^\circ\text{--}15^\circ$) dominate with 97–99%.

Fig. 7 Frequency of the different slopes in the Vistula River bottom in selected vertical cross-sections: **a** A–A', **b** B–B', **c** C–C', **d** D–D', **e** E–E', **f** F–F', **g** map of the Vistula River bottom slopes with marked location in selected vertical cross-sections

When evaluating the spatial distribution of the slopes in the map (Fig. 7g), there are the following trends. The first most important trend is the fact that the steepest slopes (red and yellow colour) have a different character in study areas 1 and 2. This is explained by the fact the steep slopes are found only in study area 1, which corresponds to the heterogeneous distribution of the erosion manifestations with maximum manifestations in the three dominant potholes. The erosion processes in river alluvia are responsible for the formation of potholes as reported in Spotila et al. (2015), Dhali and Sahana (2017), Rannie (2017) and Ji et al. (2018, 2019). However, study area 2 is characterized by distributed sedimentation processes. The sedimentation processes in the river alluvia cause sediment accumulations and formation of morphological elevations on the river bottoms as reported in Schleiss et al. (2016), Iwuoha et al. (2016) and Blum (2019).

The percentage of steeper slopes in the erosion potholes in study area 1 is clearly higher than the spatial distribution of the slopes in study area 2, where nearly all of the study area is green (Fig. 7g). This corresponds to the slope degrees 0°–10°, particularly below 5° due to the spatial sedimentation downstream of the weir channel. On the contrary, in study area 1 the percentage of slope degrees 10°–40° is clearly higher due to the erosion in the power plant channel.

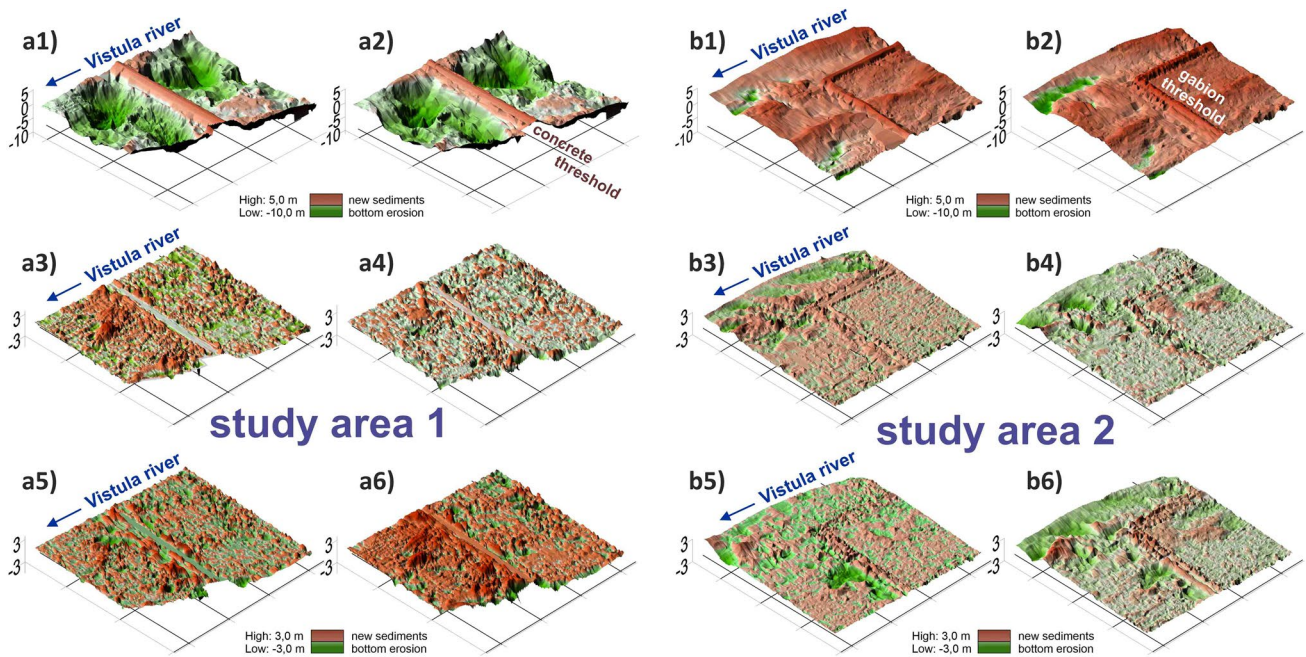
When evaluating the 4-year monitoring (Figs. 8, 9) in terms of the overall quantity of eroded materials and formation of new sediments, we found the following trends. We identified a variable trend of erosion and sedimentation in both study area 1 (Fig. 8a1, a2) and study area 2 (Fig. 8b1, b2). Erosion prevailed in study area 1, while sedimentation dominated in study area 2. Although this trend was not very clear on the basis of the 4-year monitoring (study area 1—Fig. 8a3 to a6 and study area 2—Fig. 8b3 to b6), this is corroborated by the results obtained since the dam was construction. Based on this comparison, we see the dominance of erosion in study area 1 (Fig. 9a1, a2) with the value of 168,111 m³ of gravel alluvium, which corresponds to 53.8 Olympic-size pools. Although study area 2 experienced both erosion and sedimentation during the 4-year monitoring, the monitoring

Fig. 8 Map of study areas with marked erosion and sedimentation, **a** study area 1, **b** study area 2—**a1**, **b1** digital model in the first year of monitoring, **a2**, **b2** digital model in the last year of monitoring, **a3**, **b3** marked changes in erosion and sedimentation between the first and second year of monitoring, **a4**, **b4** marked changes in erosion and

sedimentation between the second and third year of monitoring, **a5**, **b5** marked changes in erosion and sedimentation between the third and fourth year of monitoring, **a6**, **b6** marked changes in erosion and sedimentation between the first and fourth year of monitoring

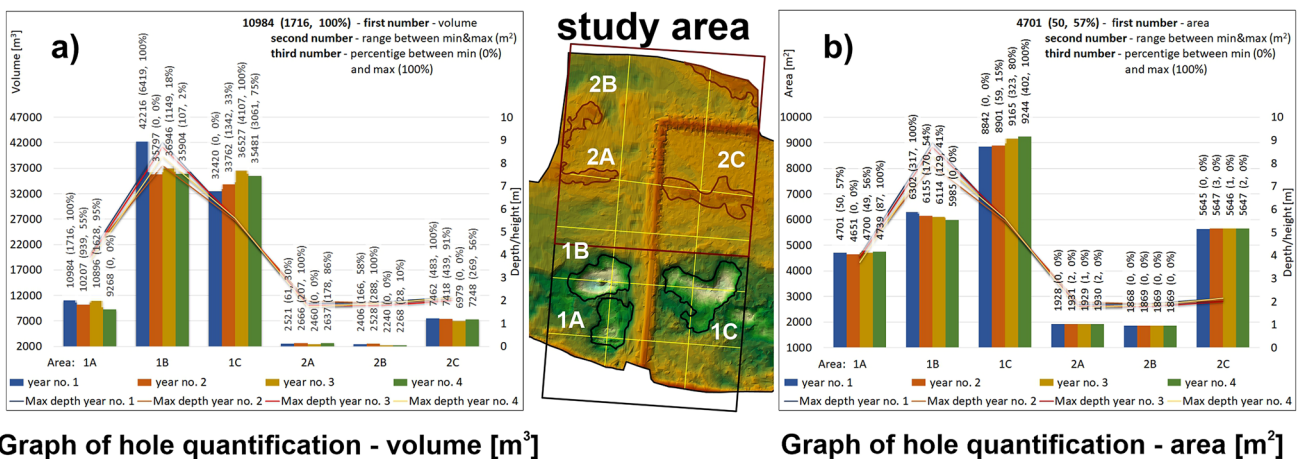
volume was observed in pothole 1B in the north downstream threshold in study area 1. Its maximum cubic volume was observed in the first year of monitoring, i.e. $42,216 \text{ m}^3$. The minimum cubic volume was observed in the fourth year of monitoring, i.e. $35,904 \text{ m}^3$. The cubic volume of pothole 1C was similar to pothole 1B. The difference lies in the fact that the first pothole 1B was filled mostly with sediments during the 4 years, while in pothole 1C, erosion prevailed. The smallest pothole was pothole 1A with maximum cubic volume of $10,984 \text{ m}^3$; it is located in the south downstream threshold. This is explained by the fact that the main erosion channel with higher flow rates and stronger water flows occurs more northwards.

Fig. 10 Quantification of selected potholes in study areas 1 and 2, **a** graph of pothole quantification—volume (m³), **b** map of study area 1 with localization potholes (1A, 1B and 1C) and study area 2 (potholes 2A, 2B and 2C), **c** graph of pothole quantification—area (m²)

Upon the evaluation of the surface area of the features, it roughly corresponds to their cubic volumes (Fig. 10c). In other words, the biggest potholes take up the largest surface areas.

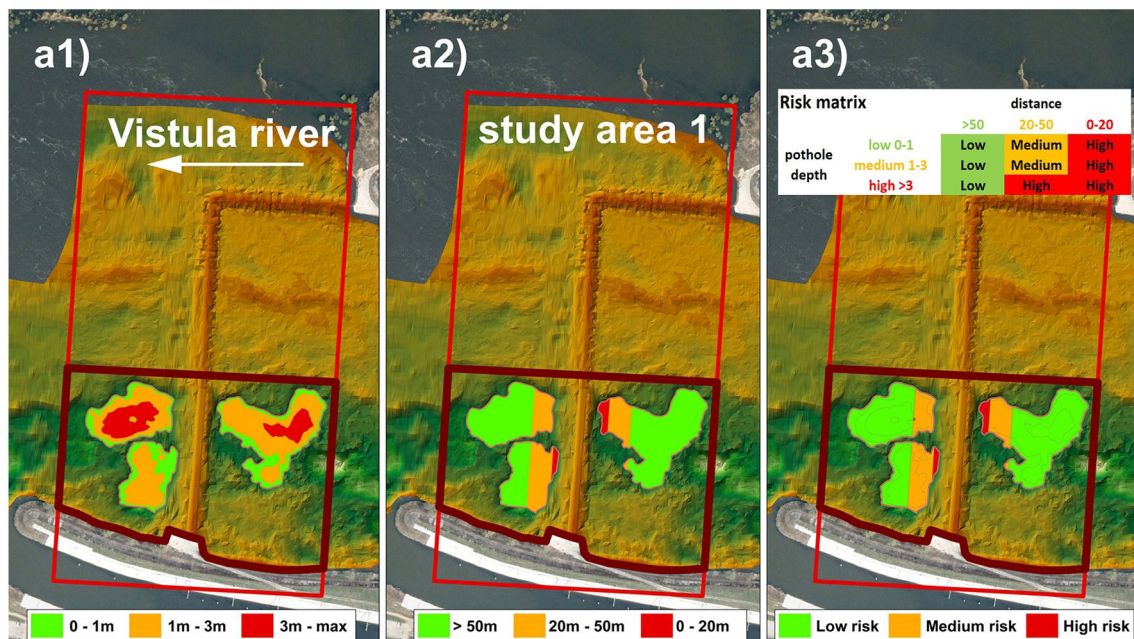
To evaluate the hazards in study area 1, we selected an approach (Fig. 11) that aims to describe the conditions of the alluvium bottom related to the threshold. The threshold in study area 1 is most endangered by erosion manifested in the form of potholes. Potholes which are too close too deep may lead to the destruction of the threshold. To address this situation, we selected two criteria to evaluate the hazards in the Vistula River alluvium near the threshold.

The first criterion is the depth of the pothole parts. Based on empirical experience in the Włocławek dam, we chose three depths. The most hazardous depth is one over 3 m. The second, conditionally hazardous, depth is 1 to 3 m, and the third, the least hazardous depth is less than 1 m (Fig. 11a). According to Fig. 12a1 and a2, the most hazardous depth corresponds to 18% of pothole volumes (7932 m^3) and 30% of surface area (5878 m^2) of study area 1. The conditionally

For the final risk evaluation map, we used a risk matrix stated in Fig. 11c, where the most hazardous group are all pothole parts closer than 20 m in all depths as well as potholes 20–50 m from the threshold with the depth over 3 m. The second, conditionally hazardous group, are pothole parts that are located 20–50 m and fall in the low (0–1) and medium (1–3) depth categories. The third, least hazardous group, are all pothole parts located over 50 m from the threshold, in all their depths. Upon the evaluation of the final risk map (Fig. 12c1, c2), the quantification corresponds to the quantification based on the second criterion discussed above. This is explained by the

Fig. 11 Map of hazards in study area 1, **a** criterion 1—pothole depth, **b** criterion 2—pothole distance from the threshold, **c** based on the combination of criteria 1 and 2 and risk matrix

The evaluation of study area 1 was based on geodetic and bathymetric measurements of pothole formation near the concrete threshold. The key for the concrete threshold stability was regular monitoring (4 years) and redevelopment through backfilling. We produced three hazard maps of study area 1. The first was based on the pothole depth, and the second on the pothole distance from the concrete threshold. The final map combined criterion 1 and 2 with the risk matrix (Fig. 11). We found that the high-risk category concerned 1% of the area (cubic volume of 510 m³) due to the potholes 1A and 1C near the gabion threshold (less than 20 m). The medium risk category concerned 17% (cubic volume of 7734 m³), where some of the potholes are within 50 m from the gabion threshold. Both categories are planned to be back-filled based on the concrete threshold redevelopment.

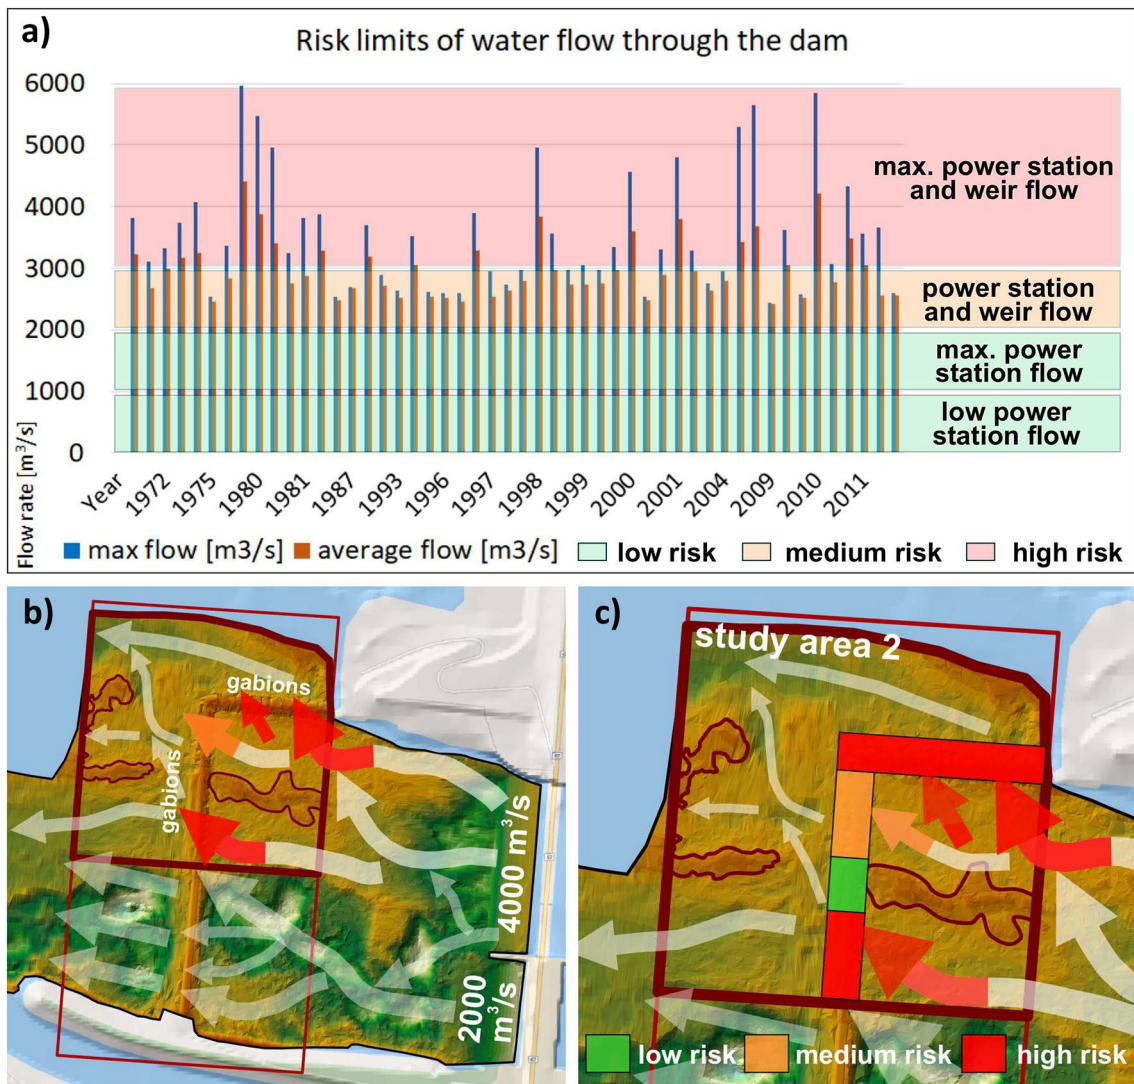
The empirical evidence shows that the gabion threshold gets damaged only during increased water flows during floods. Based on empirical evidence, we determined critical water flow rates (Fig. 13a). The most hazardous related to the gabion threshold is the flow rate over 3000 m³/s.

Fig. 13 Risk assessment in study area 2, **a** graph of risk limits of water flow through the dam, **b** potential direction of water flow by digital bottom models (DBMs), **c** risk map of the gabion threshold

The proposed methodology enabled us to characterize the more or less dominant flows that subsequently destroy the gabion threshold. The results of the model were compared with the real destruction of the gabion threshold, and it proved to correlate well with the model. This way a feedback was ensured and the risk evaluation of the gabion threshold produced (Fig. 13b, c). The study analyses the flows through the power plant (maximum is 2000) and through the weir. The flows through the power plant are systematic, even continuous, and through the weir sporadic, depending on the river flow. Critical flows over the weir during floods reach 4000 (a total of 6000 over the whole dam).

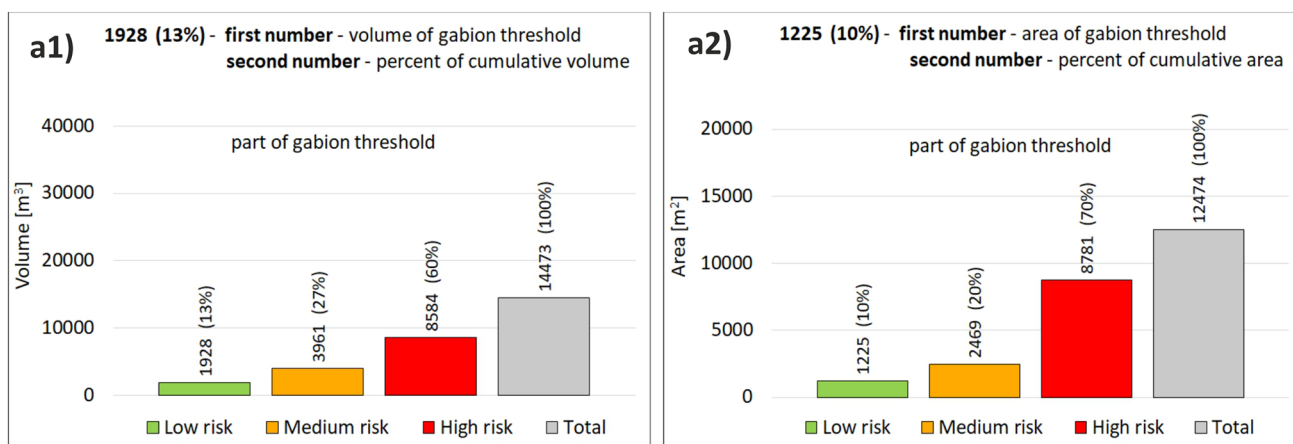
Sections of larger destructions of the gabion threshold fall in the high-risk category. We found that it concerned 64% of the threshold, i.e. 272.5 m (Fig. 14a). If we evaluate the cubic volume of the category, it adds up to 60% (8584 m³) of the cubic volume (Fig. 14b). As for the surface area, it corresponds to 70% (8781 m²) of the overall threshold area (Fig. 14c).

In the category of medium risk, smaller damage of the gabion threshold occurred. Only 26% (112 m) of the gabion threshold length was affected. Evaluating the cubic volume, the risk category adds up to 27% (3961 m³) of material from the overall cubic volume and 20% (2469 m²) of the overall threshold area.

As for the length of the gabion threshold affected by the low-risk category, it is only 10% (40.5 m) of the threshold. The cubic volume is 13% (1928 m³) of the overall cubic volume and 10% (1225 m²) of the overall threshold area.

Fig. 14 Quantification of risk categories in study area 2 according to the risk map of the gabion threshold, **a** length of gabion threshold part (m), **b** volume of gabion threshold part (m³), **c** surface area of gabion threshold part (m²)

category (40.5 m). Based on the data, it is possible to plan gabion threshold repairs on a selective basis.
