# A comparative study of hardness/scratch/wear properties of TiCN and TiAIN coatings on DIN 1.2842 steel by CA-PVD method

In the present study, TiCN and TiAlN were deposited on DIN 1.2842 (AISI O2) steel, and their mechanical properties was compared by investigating coating thickness, adhesion strength, microhardness, and elastic modulus. To carry out characterizations, micro-wear test, Rockwell C adhesion, microhardness test, and scratch test were applied on TiCN- and TiAlN-coated DIN 1.2842 (AISI O2) steel. Deposition of the TiCN and TiAlN coatings was carried out on the hardened steel substrates (55-57 HRc) at 450–500°C by cathodic arc physical vapor deposition (CA-PVD) method. As a result of the applied tests, adequate adhesion strength was obtained for both hard coatings. Through thickness microcrack, buckling failure mode and buckle spallation failure mode are observed at critical loads as Lc1, Lc2, and Lc3, respectively. TiAlN coating has better indentation hardness properties and elastic modulus. Wear resistance of TiAlN coating is better than that of TiCN coating due to similarity with substrate and tougher metallic character.

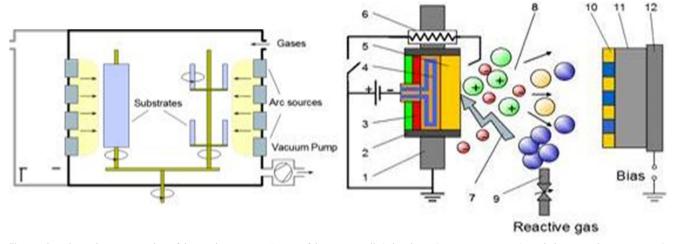
Fig. 1 The schematic representation of the coating process (1, part of the coater wall; 2, insulator; 3, magnet system; 4, cooled copper plate; 5, target; 6, ignitor; 7, arc; 8, ionized metal vapor; 9, reactive gas inlet; 10, coating; 11, tool; 12, tool holder)

Cathodic arc coating method is used to deposit TiCN and TiAlN PVD coatings on all of the steels. Coating process was performed at a temperature in the range of 450–500°C. Figure 1 shows the schematic representation of coating process.

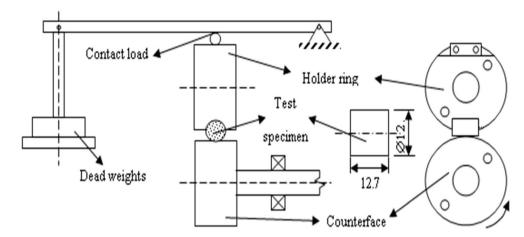
**Fig. 3** The schematic diagram of wear test apparatus

To evaluate the wear characteristics of the coatings, a pin-on-roller type of apparatus (PLINT multipurpose friction machine) was used as shown in Fig. 3. Load was controlled by adjusting manually, and revolution speed of roller was controlled and recorded to a computer automatically. The samples were loaded against the abrasive roller, which was made out of nitrided cast iron, with the help of a cantilever mechanism. The wear pin was cleaned in acetone before and after the wear tests, and then the dried pin was weighed on a microbalance with 0.1 mg sensitivity. Each test was performed with a new roller. In all wear test, the revolution speed (500 rpm) and load (67 N) are kept constant, but sliding distance is varied as 300, 600, 900, 1200, 1500, and 1800 m, and wear amount was determined for all specific cases.

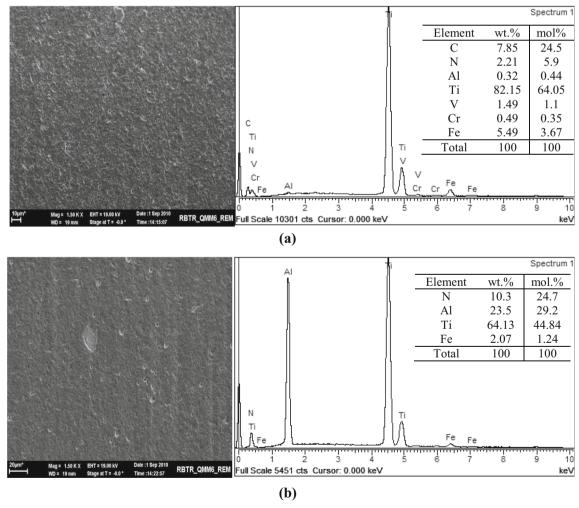
Fig. 4 ×1500 picture and EDX analysis of coatings: a TiCN and b TiAlN

Chemical composition and microstructure of the coated surfaces were also characterized by using SEM-EDX. Figure 4 shows ×1500 magnification picture and EDX analysis of the TiCN- and TiAlN ceramic-coated DIN 1.2842 (AISI O2) steel surfaces. EDX results show that, for TiCN coating, the steel peaks come from main metal due to high voltage acceleration as 19 kV, which may penetrate the electrons through 3 microns, so Fe-Cr-V elements come from main metal. When the molar ratios of elements were calculated by EDX wt%, the average TiCN formation can be evaluated as Ti<sub>0.675</sub>(C<sub>0.258</sub>N<sub>0.062</sub>). This composition is more in metallic character after subtraction of main

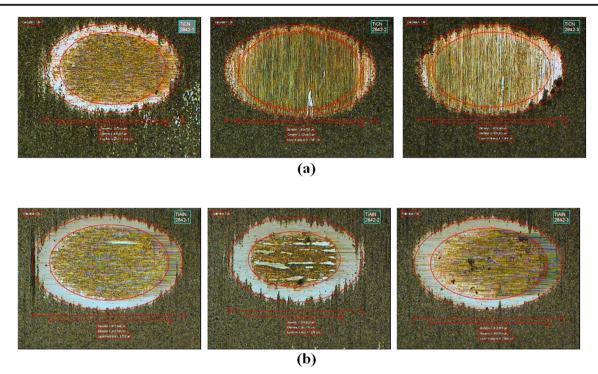
Fig. 5 Coating surfaces of abrasion wear: a TiCN and b TiAlN

TiCN and TiAlN coating thicknesses were measured on three samples using a CSM Calotest Abrasion Instrument. Figure 6 shows the tracks of Calotest abrasion. Track of abrasion test gives information about coating quality such as surface cleanness, impurities, and adhesion strength. As it is seen in Fig. 8b (middle picture), removal of coating (white color and black or gray color) was obviously seen in the inner side of elliptical attrition.

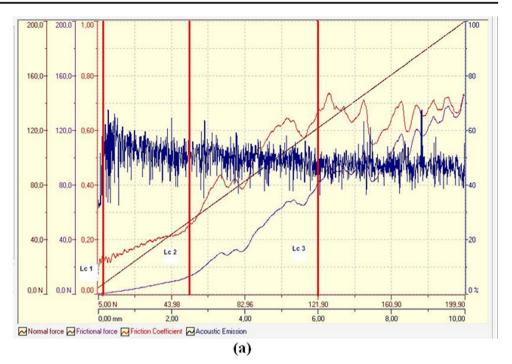
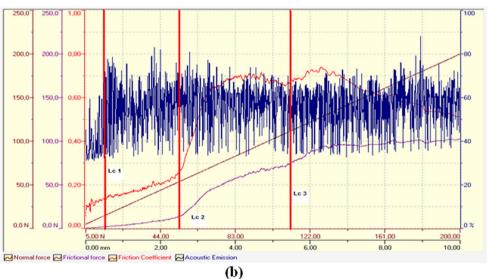
**Fig. 6** Scratch test results of DIN 1.2842 steel: **a** TiCN and **b** TiAlN

When the experiment results are investigated, the critical loads ( $L_{C1}$ ,  $L_{C2}$ ,  $L_{C3}$ ) are defined by analyzing three significant parameters, which are acoustic signal, friction force, and friction coefficient.  $L_{C1}$  is determined critical load point, where the acoustic signal rises immediately.  $L_{C2}$  is critical load point where the friction force and friction coefficients increase at the same time with a higher slope. The location, where the acoustic signal and the friction coefficient started to create straight lines, is the determined location of  $L_{C3}$  critical load.

The average values of TiCN and TiAlN coating properties were compared. While the critical load ( $L_{C1}$ ) where the first microcrack occurred for TiCN coating is 7.92 N at 0.15 mm distance, for TiAlN coating  $L_{C1}$

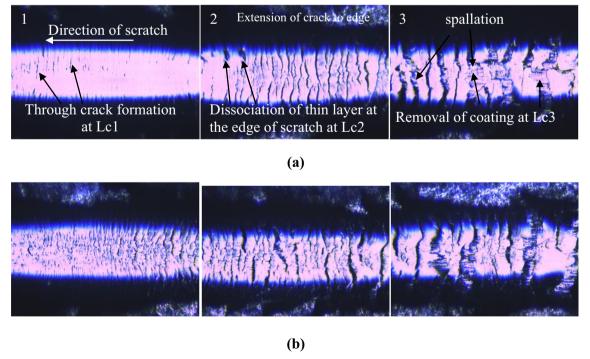
Fig. 7 The optical microscopy top view of the scratch lines and critical loads obtained from scratch test for DIN 1.2842 steel: a TiCN and b TiAlN

The groove created in the scratch test was examined using an optical microscope with  $\times 200$  magnification in order to determine the failure mode. Figure 8 shows the formation of through thickness microcrack ( $L_{\rm C1}$ ), load bearing capacity ( $L_{\rm C2}$ ), and complete removal of the coating ( $L_{\rm C3}$ ) for TiCN and TiAlN coatings of DIN 1.2842 steel. In both coatings, the through thickness cracks occur at the critical load of  $L_{\rm C1}$  (Fig. 8a1 and b1).

Through thickness cracks in the TiCN coating are fine and less amount as compared to cracks in the TiAlN coating. At critical load of  $L_{\rm C2}$ , buckling failure mode was observed in both coatings. Buckling failures typically appear as curved cracks extending to the edges of or beyond the scratch track (Fig. 8a2 and b2). In this failure mode, failure occurs in response to the compressive stresses generated ahead of the moving indenter. Localized regions containing interfacial defects allow the coating to buckle in response to the stresses. Individual buckles spread laterally by propagation of interfacial crack. At the critical load of  $L_{\rm C2}$ , slopes of coefficient of friction and frictional force increase sharply (Fig. 7a and b). At the critical load of  $L_{\rm C3}$ , buckle spallation failure mode was observed. Removal of coating occurs when through thickness cracks form in regions of high tensile stress within the coating.

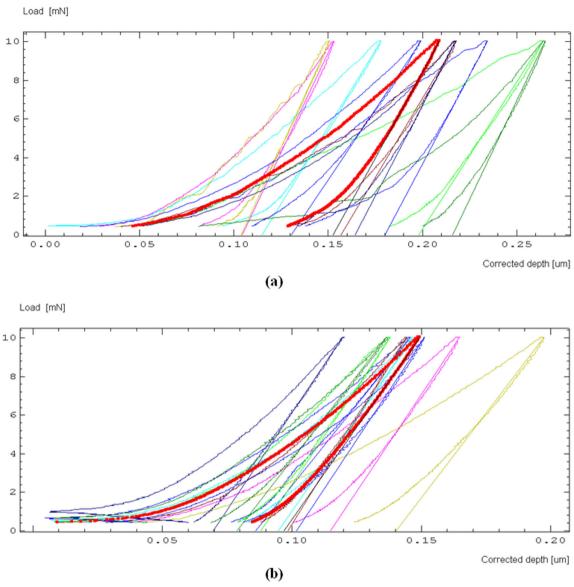
Fig. 8 Load-depth diagram obtained after dynamic microhardness test for a TiCN and b TiAlN coatings. The graphs include 9 tests and the average curve (red curve)

Dynamic microhardness tests were performed on each sample for 10 times, and the worst test was eliminated; therefore, 9 indentations were used for calculations in order to get reliable results. Figure 9 shows the load vs. depth diagram for 9 tests of TiCN and TiAlN coatings and the software calculated mean curve (red color) for both type of coatings.

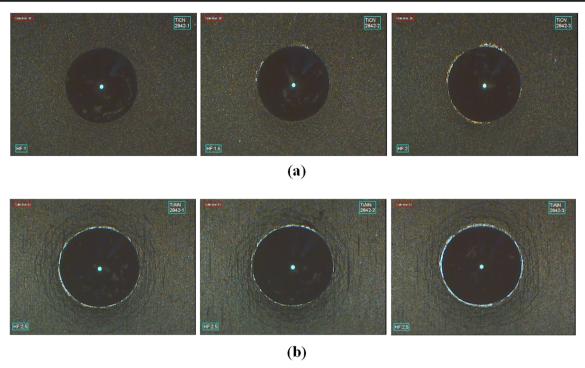
Fig. 9 Rockwell C adhesion test for 1.2842: a) TiCN (HF=1, HF=1.5, HF = 2) and b) TiAlN (HF = 2.5, HF=2.5, HF=2.5)

This is the most commonly used test in industry for determining the quality of a coating. Figure 9 shows the Rockwell C adhesion test marks on the surface of steels, respectively. If HF value is above 4, then it means that the coating does not have enough adhesion strength on the surface. This adhesion strength can be concluded as the negative (compression) stress that leads to a better bonding when illustrated in images.

As seen in Fig. 9, HF values for TiCN and TiAlN coatings determined below 4 using the reference images for comparison by the software that was described in standards, respectively. It means that the coatings have high enough adhesion strength to make itself adequate to use. When two coatings are compared, adhesion strength of TiCN coating can be said better than that of TiAlN coating since HF values of TiCN coating are smaller than that of TiAlN coating. TiCN is a more similar coating to substrate than TiAlN by means of elemental composition on DIN 1.2842. The elements of interest in TiCN can be evaluated closer to carbon ratio of DIN 1.2842 by surficial. The carbon content of TiCN was estimated to be around 0.2–0.3 which can be similar on the surface of DIN 1.2842 that may lead to the same C content to form better bonds as well as N, since N is not present on substrate, but has an advantage of bonding to form nitride by Fe as of C.
