Condition and characterization analysis of a twentieth century cultural heritage through non-destructive testing (NDT) methods: the case of the Sivas industry school ironworking atelier in Turkey

Gamze Fahriye Pehlivan*

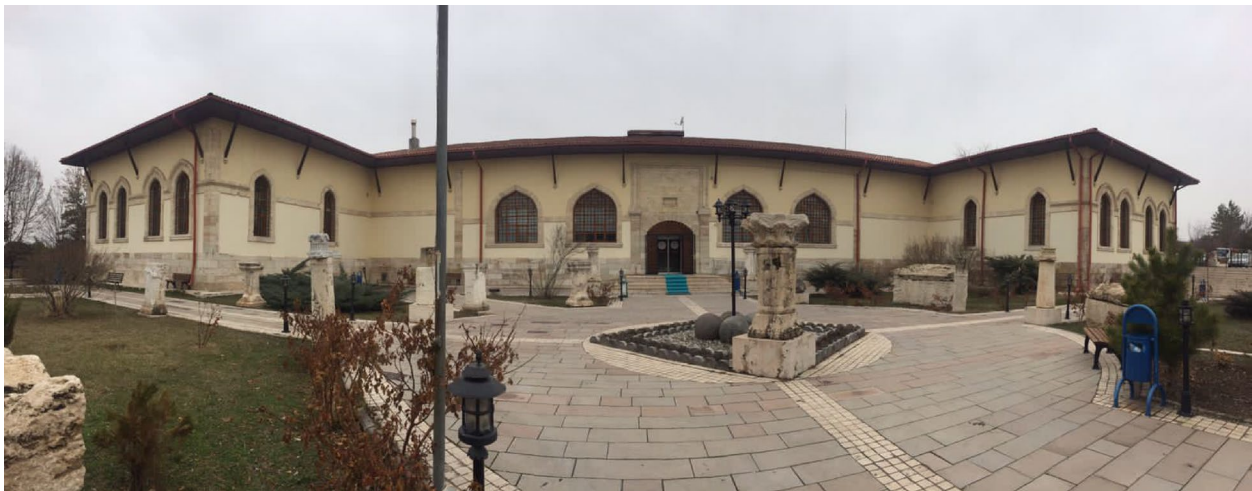
Fig. 4 Eastern facade of the Industry School Ironworks Atelier (panoramic photo)

In the corners to the north and south of the U-plan building, the spaces projected from the plan stand out. The façades of these spaces were built with ashlar up to the moulding level. The mouldings, corners, window casings, and window sills of the building are

also constructed of ashlar. The windows are tangential arches, and the doors on the eastern, southern, and northern fronts are depressed arches. The wide eaves of the hipped roof building are supported by angle braces (Fig. 4) [23, 27].

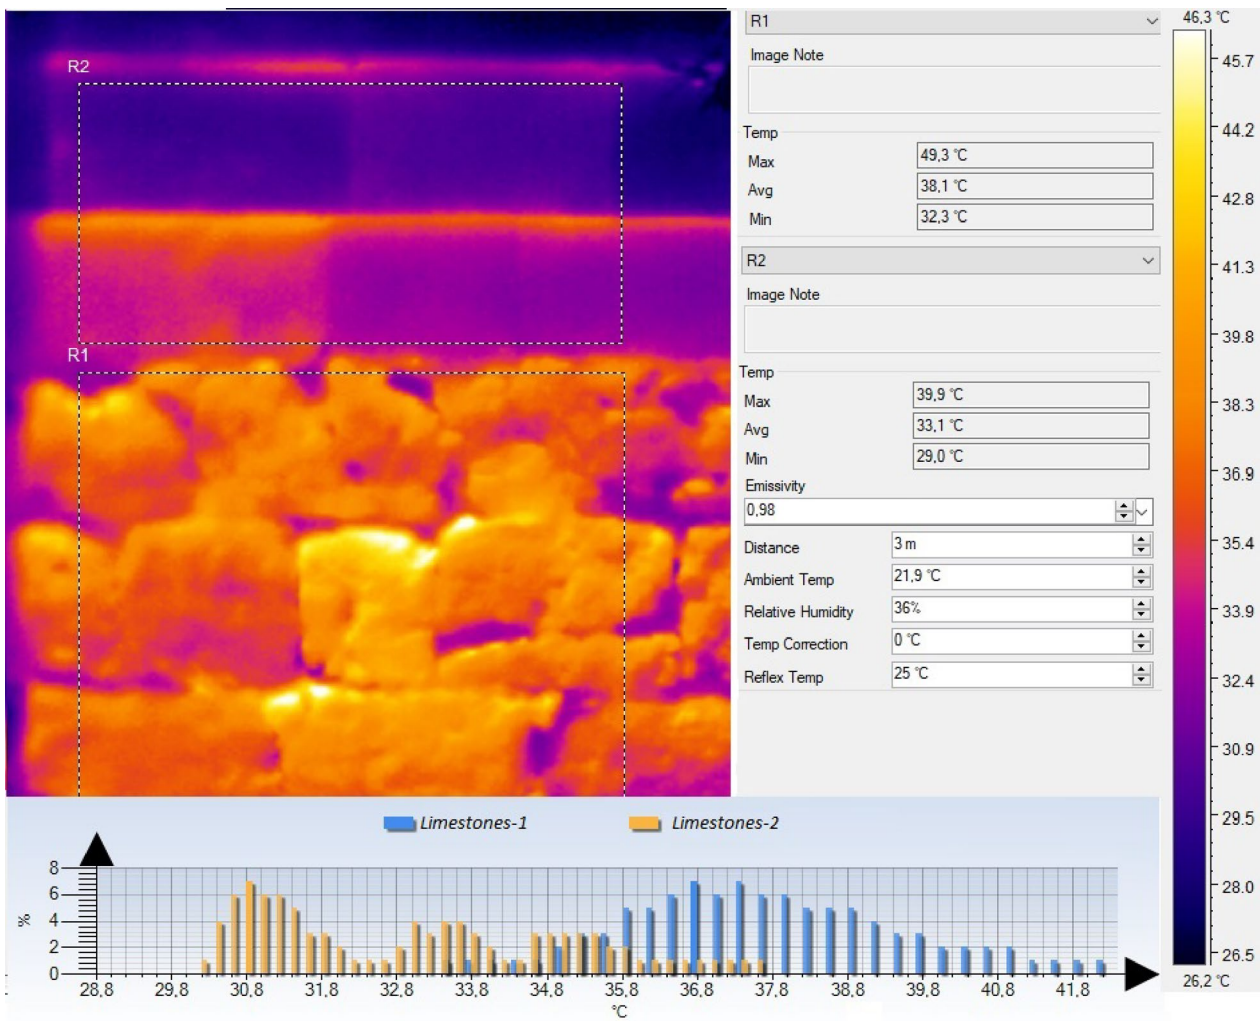
Fig. 6 Graphic of the surface temperature of limestone-1 and limestone-2

Ashlar also exhibited a lower visible cavities than when it was extracted from the quarry for the abovementioned reasons [109–111]. This caused rapid heat transmission, causing the temperature of ashlar to be lower than that of the pitch-faced stones.

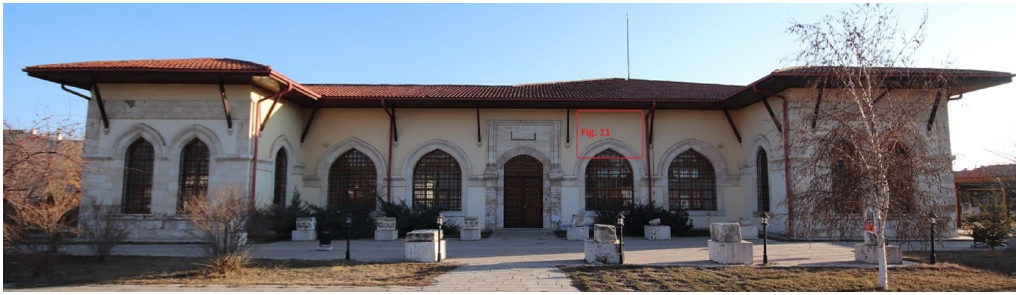
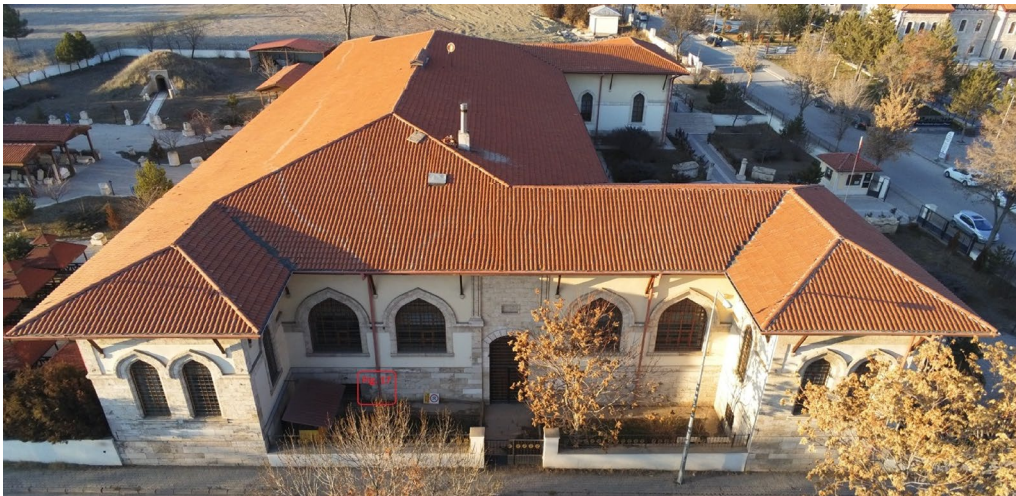
Fig. 7 Western facade of the Industry School Ironworks Atelier

Fig. 8 Northern facade of the Industry School Ironworks Atelier

Fig. 9 Southern facade of the Industry School Ironworks Atelier

As a result of IRT scanning of the building, anomalies could be detected underneath plaster (Figs. 7, 8, 9). Although it is known that the building is constructed of stone, the thermal image in Fig. 10 shows that underneath the plaster layer, different material than stone (possibly brick?) was used in the building. This indicates that this window was once used as a door, filled with various materials during the restoration phase and converted

into a window. In addition, there occurred paint spills and plaster blisters on the wall surface.

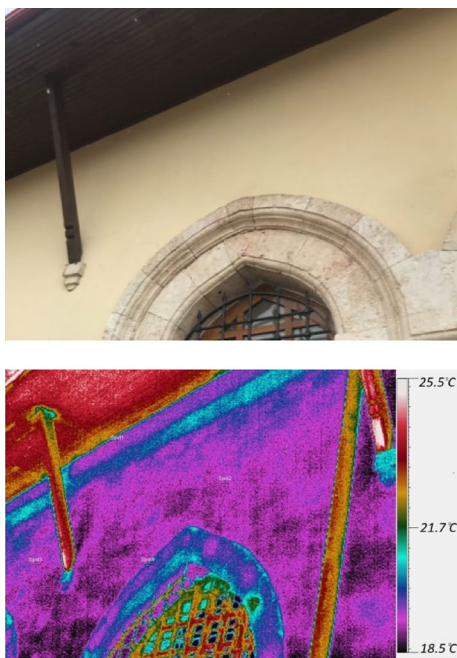
Figure 11 shows that the different building materials, seemingly with or without any deterioration, were not visible to the naked eye and occurred below the plaster layer but could be detected via the IRT method. The wooden beam, which continues along the horizontal line under the eave, was not observed in the digital camera image but could be detected with the thermal camera. This image emerged due to the difference between the thermal conductivity coefficient of the wooden beam and that of the stone wall (Fig. 12).

Fig. 12 IRT detection of invisible building materials underneath plaster

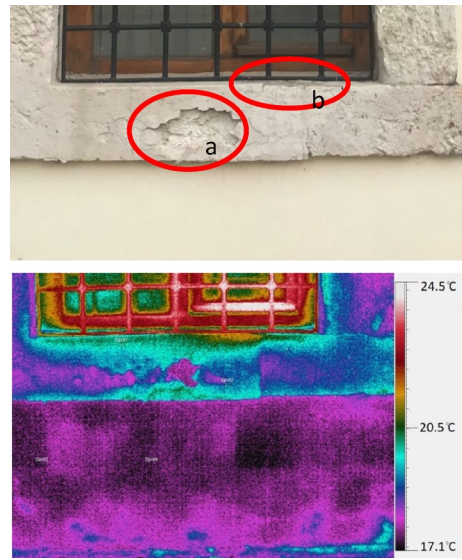
Figure 16 shows that the limestone of the window sill was blistered at Point a, and this blistered piece fell. Since the part that fell is very large in size, dry air was not trapped, similar to small porous thermal insulation materials. In contrast, this region exhibited a lower temperature than that of the building material, as the humid air accumulated here increased heat transmission via conduction. Figure 15 shows that this area was warmer than the other surfaces, as described above, since there are small pores at Point b.

Fig. 16 a Blistering of the limestone window sill; b pores in limestone

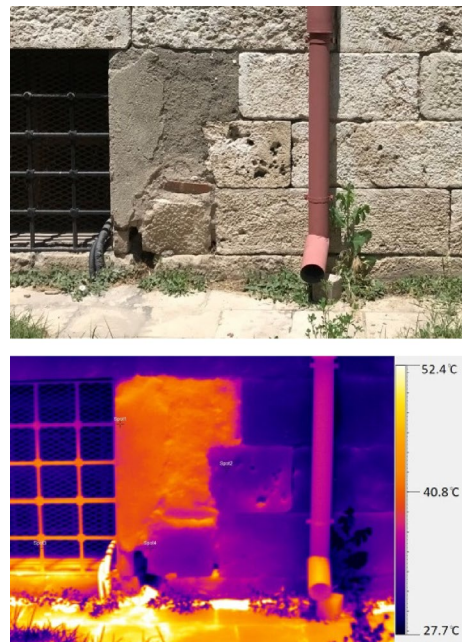
As an unqualified intervention shown in Fig. 17, part of the wall was plastered with cement plaster, and the surface temperatures differed because of the different thermal conductivity coefficients of cement plaster and stone. In addition, as shown in the digital image, plants grew at the junction of the wall and ground level. These plants, which grow uncontrolled between the joints of the stones or on the surface where the wall meets the ground level,

could damage the stone due to their acidic effect. Even if the roots of these plants were weak, they could create problems such as maintaining moist stones and causing salt accumulation [62].

Fig. 17 Detection of plant growth and material differences with the thermal camera
