Engineering–geological investigation of the river bottom near a dam’s stabilization threshold based on two different evaluation methodologies

Keywords Engineering–geological investigation · Threshold · Vistula River alluvium · Włocławek dam · Geodetic/bathymetric measurements

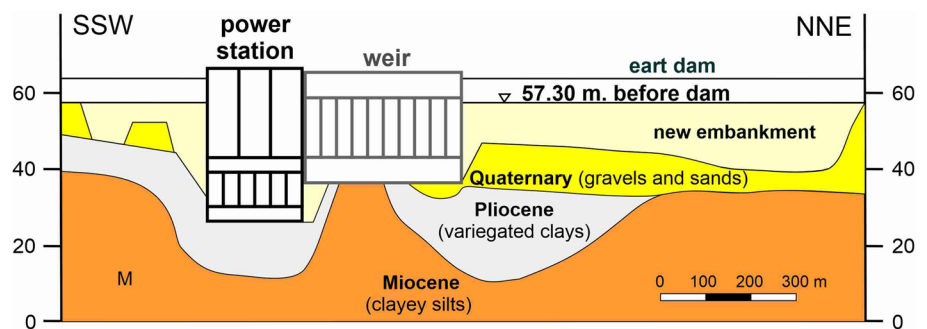
The geological structure of the study area (Fig. 4) contains Miocene clayey silts, topped by Pliocene variegated clays and Quaternary gravels and sands, where potholes occur.

Fig. 4 Engineering–geological cross-section of the study area

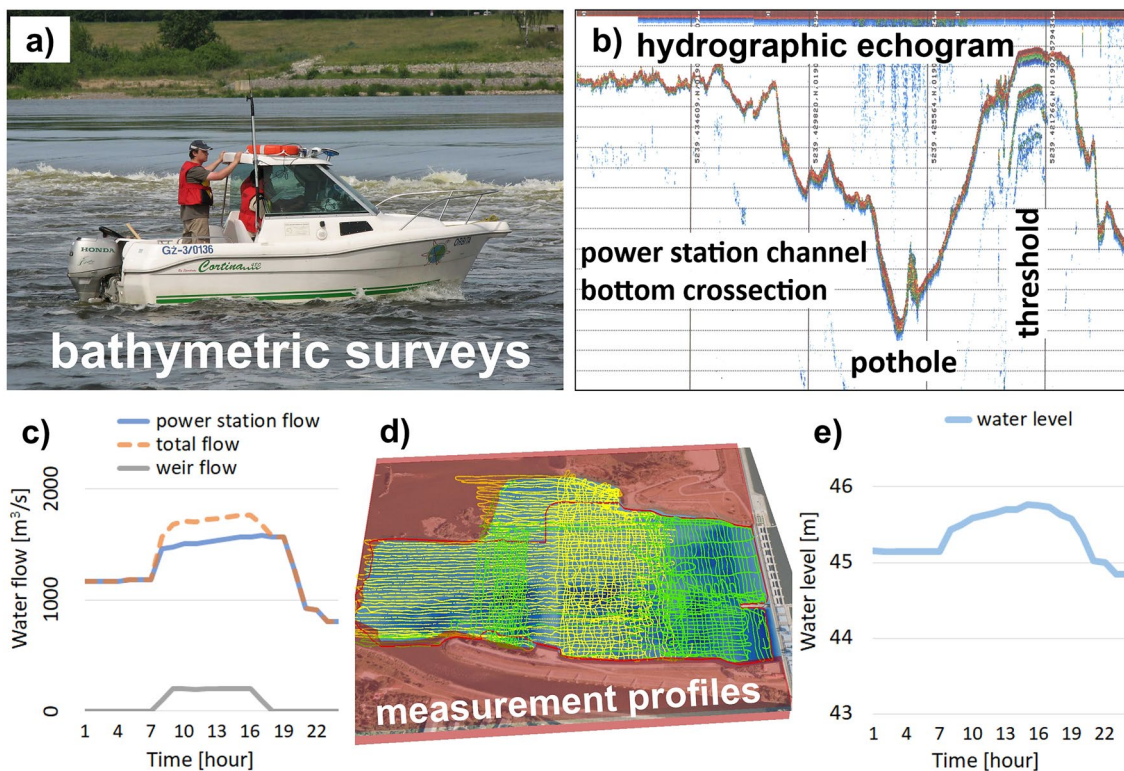
professional single-beam echosounder covered both the area of the bottom upstream and downstream threshold as well as the threshold itself. Figure 5a shows a bathymetric boat *Orbita* taking depth measurements directly above the pothole (about 38 m ASL) just behind the threshold (45 m ASL). The pothole with a depth of about 9 m is shown in the echogram in Fig. 5b. On the right side of the echogram, the threshold is clearly visible. This place is also visible in Fig. 5a just in front of the boat, where the water level change and its turbulent and disturbed flow can be seen. During the measurements, the water flow varied and depended on the operation cycle of the power plant and the weir. Figure 5c shows the flows through the weir and power plant as well as the total water flow of 1760 m³/s. Depending on the total flow, measurements were made on different parts of the reservoir behind the Włocławek hydroelectric power plant (Fig. 5d). The water flow also affected the water level, which determined the stages of geodetic and bathymetric surveys (Fig. 5e). In addition, during a power plant break (total flow 0), the water level dropped so that the conventional total station surveying (using Leica TS 15) was carried out on the exposed threshold. The collected measurement data were used to develop a three-dimensional model of the threshold and the Vistula River bottom (Fig. 3a, b, c).

Fig. 5 Methodology of the bathymetric measurements, **a** photo-documentation of bathymetric surveys, **b** hydrographic echogram, **c** graph of water flow changes, **d** measurement profiles, **e** graph of water level changes

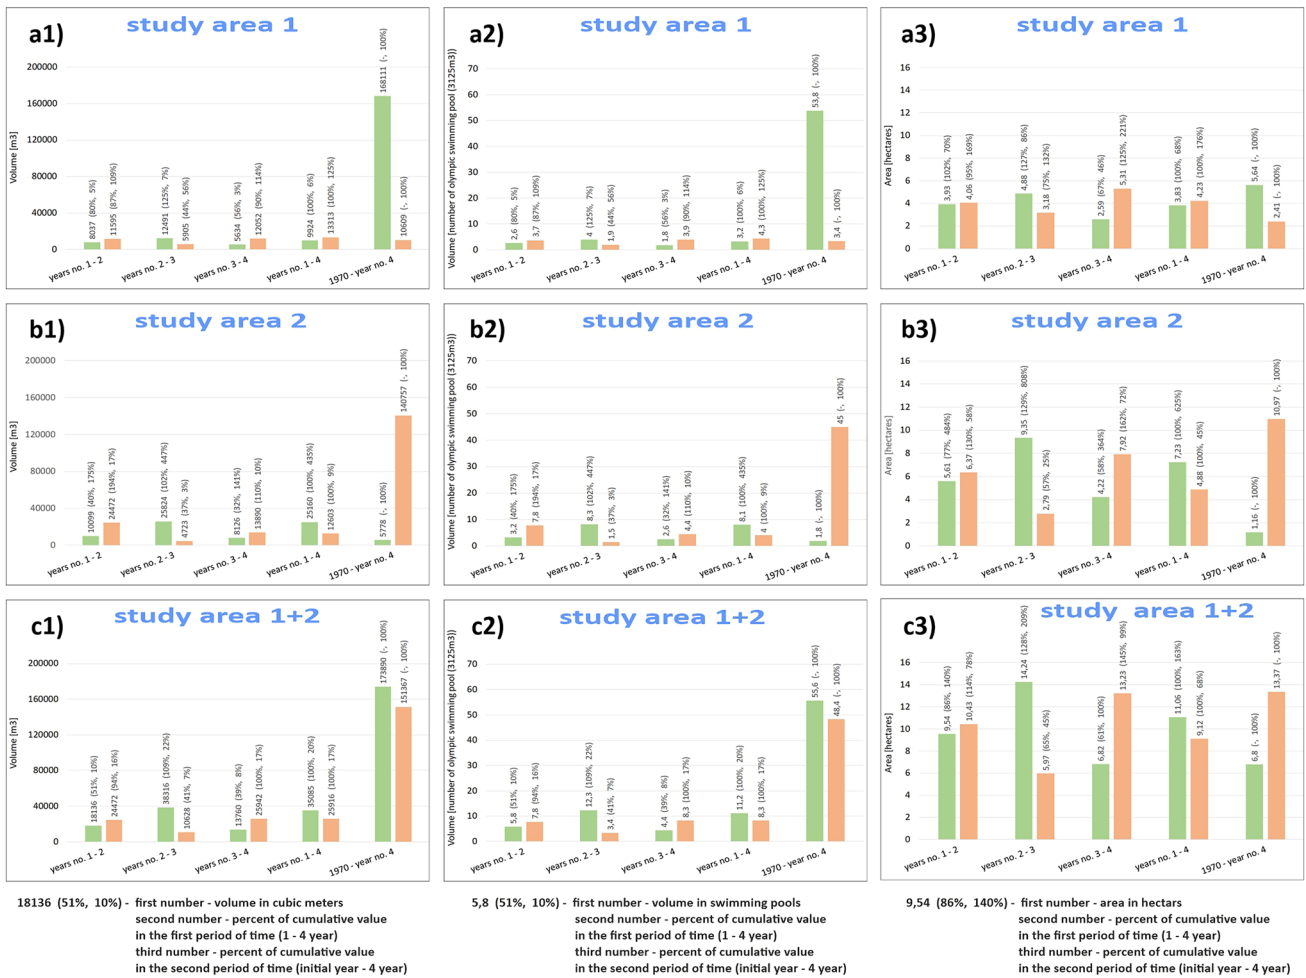
since the dam construction shows an absolute dominance of sedimentation with the value of $140,757 \text{ m}^3$ of sediments (Fig. 9b1, b2), which corresponds to 45 Olympic-size pools.

As for the quantification of surface areas, they clearly correspond to the cubic volumes (Fig. 9a3, b3). When comparing the influence of erosion and sedimentation in both study areas, we can see that erosion dominates over sedimentation, which is logical (Fig. 9a3, b3).

Fig. 9 Temporal changes of river bottom surface (bottom erosion and new sediment), **a1** study area 1—volume (m³), **a2** study area 1—volume (number of Olympic-size pools), **a3** study area 1—area (m²), **b1** study area 2—volume (m³), **b2** study area 2—volume (number of Olympic-size pools), **b3** study area 2—area (m²), **c1** study area 1 + 2—volume (m³), **c2** study area 1 + 2—volume (number of Olympic-size pools), **c3** study area 1 + 2—area (m²)

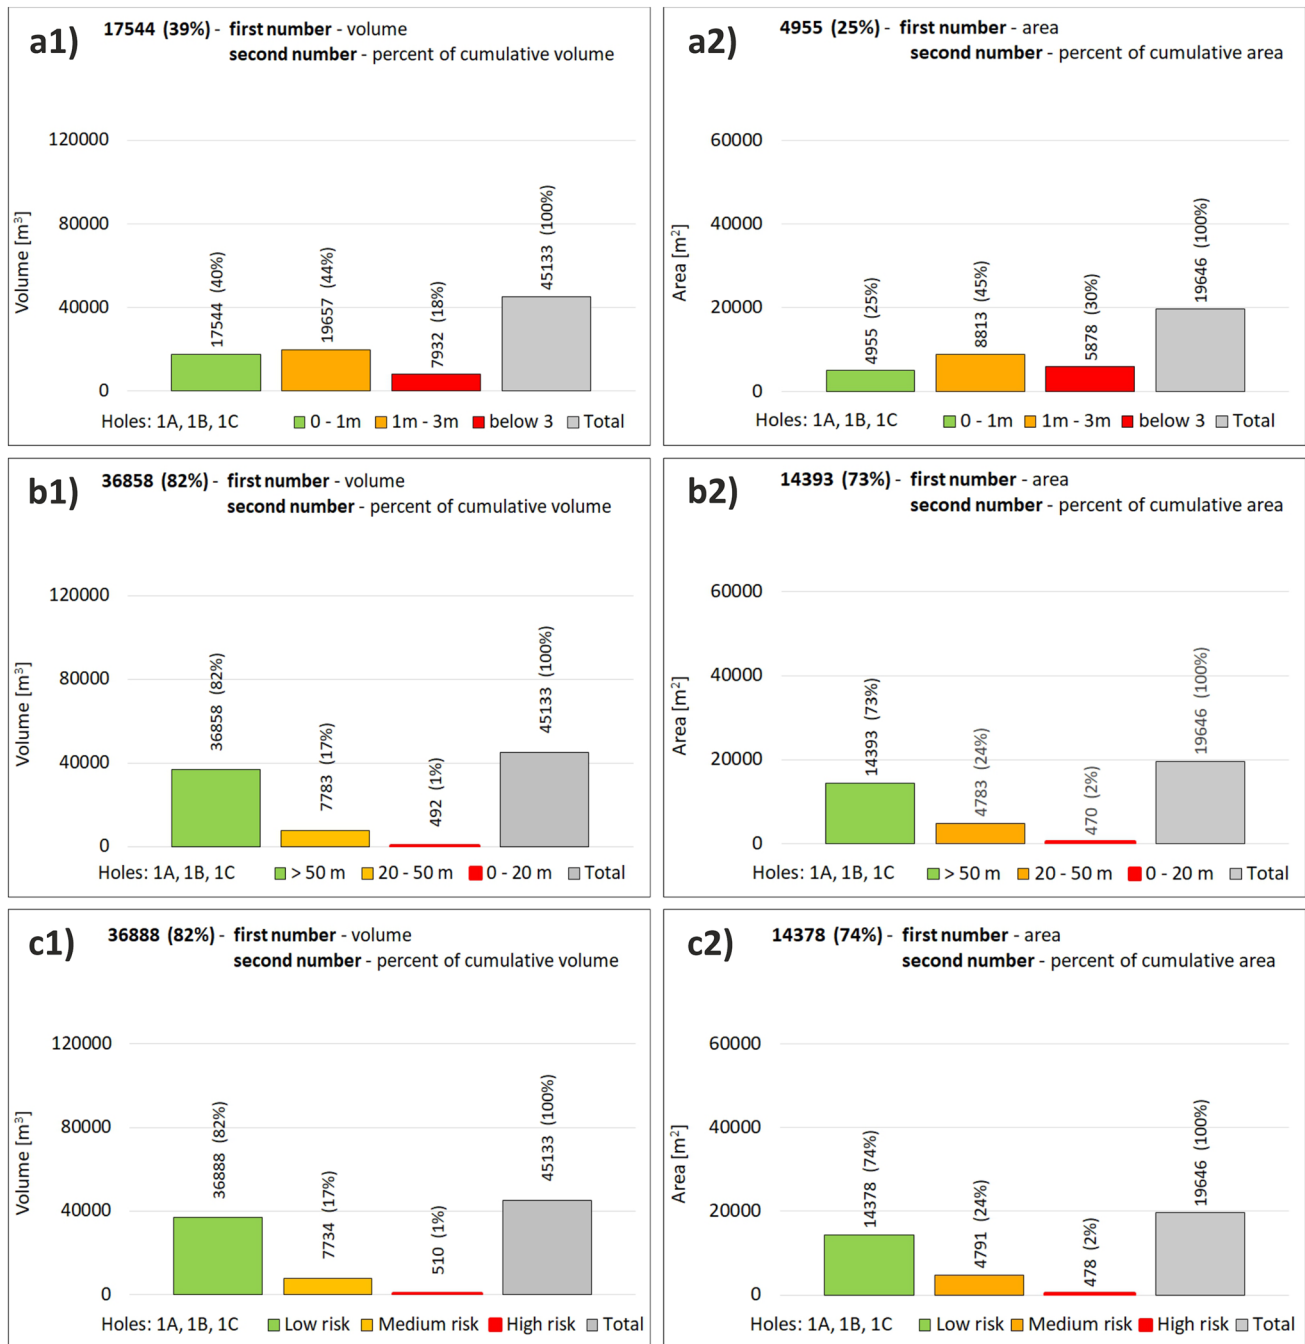
The first criterion is the depth of the pothole parts. Based on empirical experience in the Włocławek dam, we chose three depths. The most hazardous depth is one over 3 m. The second, conditionally hazardous, depth is 1 to 3 m, and the third, the least hazardous depth is less than 1 m (Fig. 11a). According to Fig. 12a1 and a2, the most hazardous depth corresponds to 18% of pothole volumes (7932 m^3) and 30% of surface area (5878 m^2) of study area 1. The conditionally

The second criterion is the distance of the pothole from the threshold. The most hazardous distance is below 20 m from the threshold, the second (conditionally) hazardous distance is 20–50 m from the threshold, while the least hazardous distance of the pothole is over 50 m (Fig. 11b). As for the quantification of the second criterion (Fig. 12b1, b2), it showed that only 1% of pothole volume (492 m^3) and 2% of surface area (470 m^2) in study area 1 fall in the most hazardous category. The conditionally hazardous distance corresponds to 17% of pothole volume (7783 m^3) and 24% of surface area (4783 m^2). The least hazardous distance is related to 82% of pothole volume ($36,858 \text{ m}^3$) and 73% of surface area ($14,393 \text{ m}^2$).

For the final risk evaluation map, we used a risk matrix stated in Fig. 11c, where the most hazardous group are all pothole parts closer than 20 m in all depths as well as potholes 20–50 m from the threshold with the depth over 3 m. The second, conditionally hazardous group, are pothole parts that are located 20–50 m and fall in the low (0–1) and medium (1–3) depth categories. The third, least hazardous group, are all pothole parts located over 50 m from the threshold, in all their depths. Upon the evaluation of the final risk map (Fig. 12c1, c2), the quantification corresponds to the quantification based on the second criterion discussed above. This is explained by the

Fig. 12 Quantification of study area 1 based on risk map (pothole 1A, 1B and 1C), **a1** based on criterion 1—depth of pothole parts—volume (m³), **a2** based on criterion 1—depth of pothole parts—surface area (m²), **b1** based on criterion 2—pothole distance from the thresh-

old—volume (m³), **b2** based on criterion 2—pothole distance from the threshold—surface area (m²), **c1** based on the combination of criteria 1 and 2 and risk matrix—volume (m³), **c2** based on the combination of criteria 1 and 2 and risk matrix—surface area (m²)

The evaluation of study area 1 was based on geodetic and bathymetric measurements of pothole formation near the concrete threshold. The key for the concrete threshold stability was regular monitoring (4 years) and redevelopment through backfilling. We produced three hazard maps of study area 1. The first was based on the pothole depth, and the second on the pothole distance from the concrete threshold. The final map combined criterion 1 and 2 with the risk matrix (Fig. 11). We found that the high-risk category concerned 1% of the area (cubic volume of 510 m³) due to the potholes 1A and 1C near the gabion threshold (less than 20 m). The medium risk category concerned 17% (cubic volume of 7734 m³), where some of the potholes are within 50 m from the gabion threshold. Both categories are planned to be back-filled based on the concrete threshold redevelopment.
